**CONSTRUCTION QUALITY AUDIT OF  
UNDER CONSTRUCTION CGEWHO HOUSING  
PROJECT (PH-III)**

**KOLKATA, WEST BENGAL**

**Department of Civil Engineering  
Indian Institute of Technology Roorkee  
Roorkee, 247667  
(April 2025)**

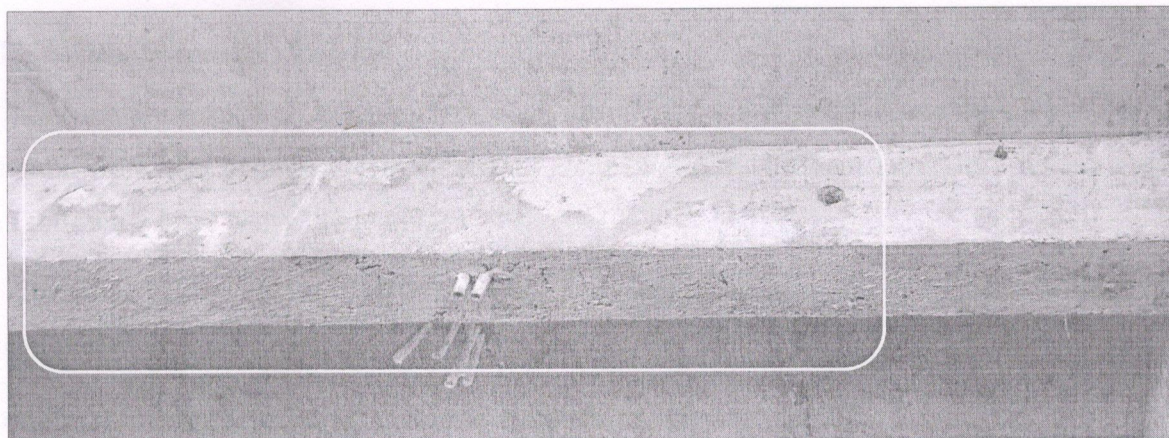
Overall, the construction quality appeared satisfactory, with no major defects observed in the completed structural elements. The surface finish was consistent, and no significant anomalies were identified across the buildings. However, minor surface irregularities were noted at a few isolated locations, which had already been rectified using cement mortar (see **Figure 2**). Additionally, isolated instances of honeycombing were observed in Block 3 (shown in **Figure 3**). Necessary instructions and advice were given at the site to avoid them.

*Figure 2: Few Instances of Anomalies in surface finishing*

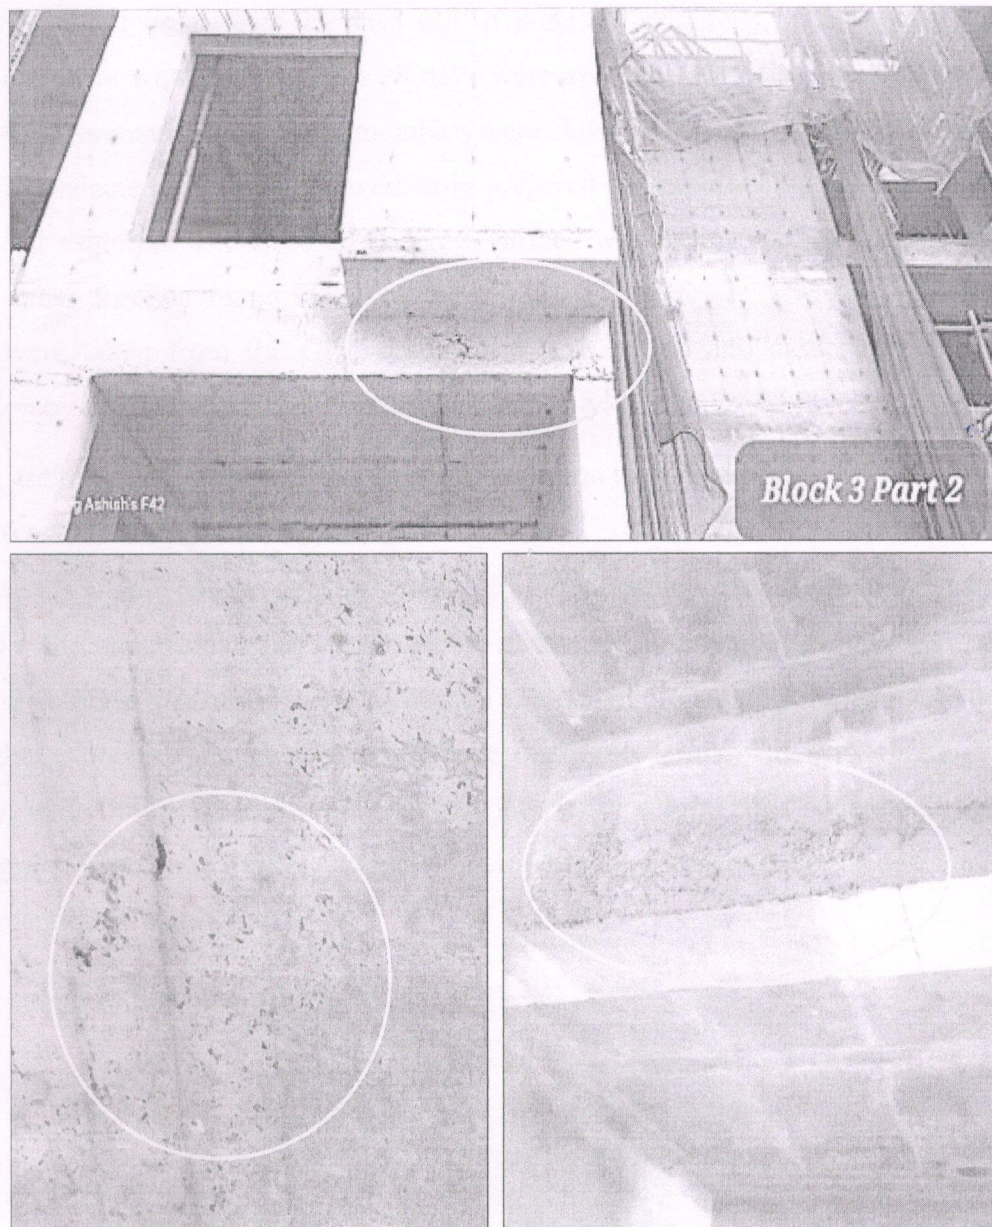
*Figure 3: Honeycombing issues at isolated locations in Block 3*
