**CONSTRUCTION QUALITY AUDIT OF  
UNDER CONSTRUCTION CGEWHO HOUSING  
PROJECT (PH-III)**

**KOLKATA, WEST BENGAL**

**Department of Civil Engineering  
Indian Institute of Technology Roorkee  
Roorkee, 247667  
(April 2025)**

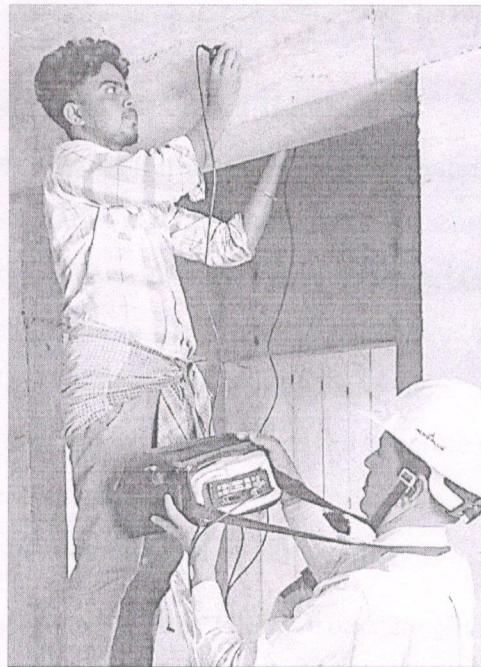
*Figure 4: Typical view of Ultrasonic Pulse Velocity Test in Progress*

According to project documentation, M30-grade concrete has been used in the ongoing construction. The test results indicate that the concrete quality at all tested locations falls within the "good" to "excellent" range, with UPV values varying between 3.78 km/s and 4.58 km/s, and an average value of 4.14 km/s. Although minor overestimation of UPV readings may occur due to residual moisture in the concrete, the overall values confirm the sound quality of the concrete. These findings align with the visual inspection, where the concrete elements were observed to be mostly free from any noticeable distress or defects.

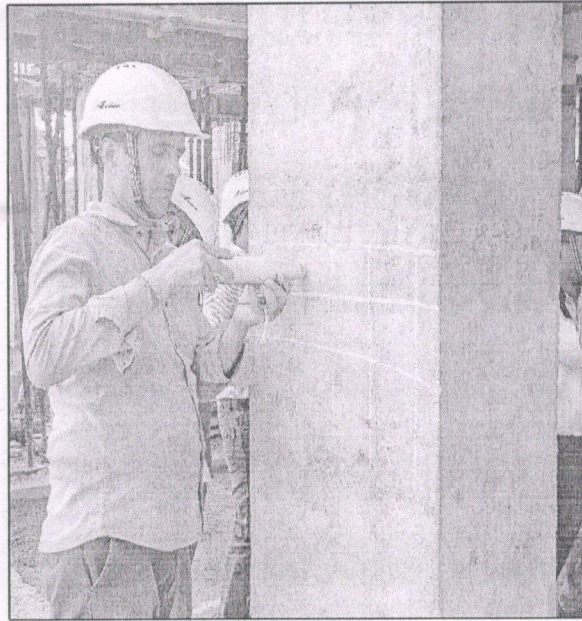
*Figure 5: Typical view of Rebound Hammer Test in Progress*

Since construction was very new, negligible carbonation is expected. This makes rebound hammer test a reliable indicator of concrete surface quality. In the present case, the rebound hammer values vary between 38 to 52, indicating good to very good concrete surface quality. Such a high value also exhibits that concrete was free from patches or delamination.
